CONFIG :HF810 18010 01100

KIT No : K327

Draw number : BG3K-K327

Title : Standard Schematic BG3000PSV

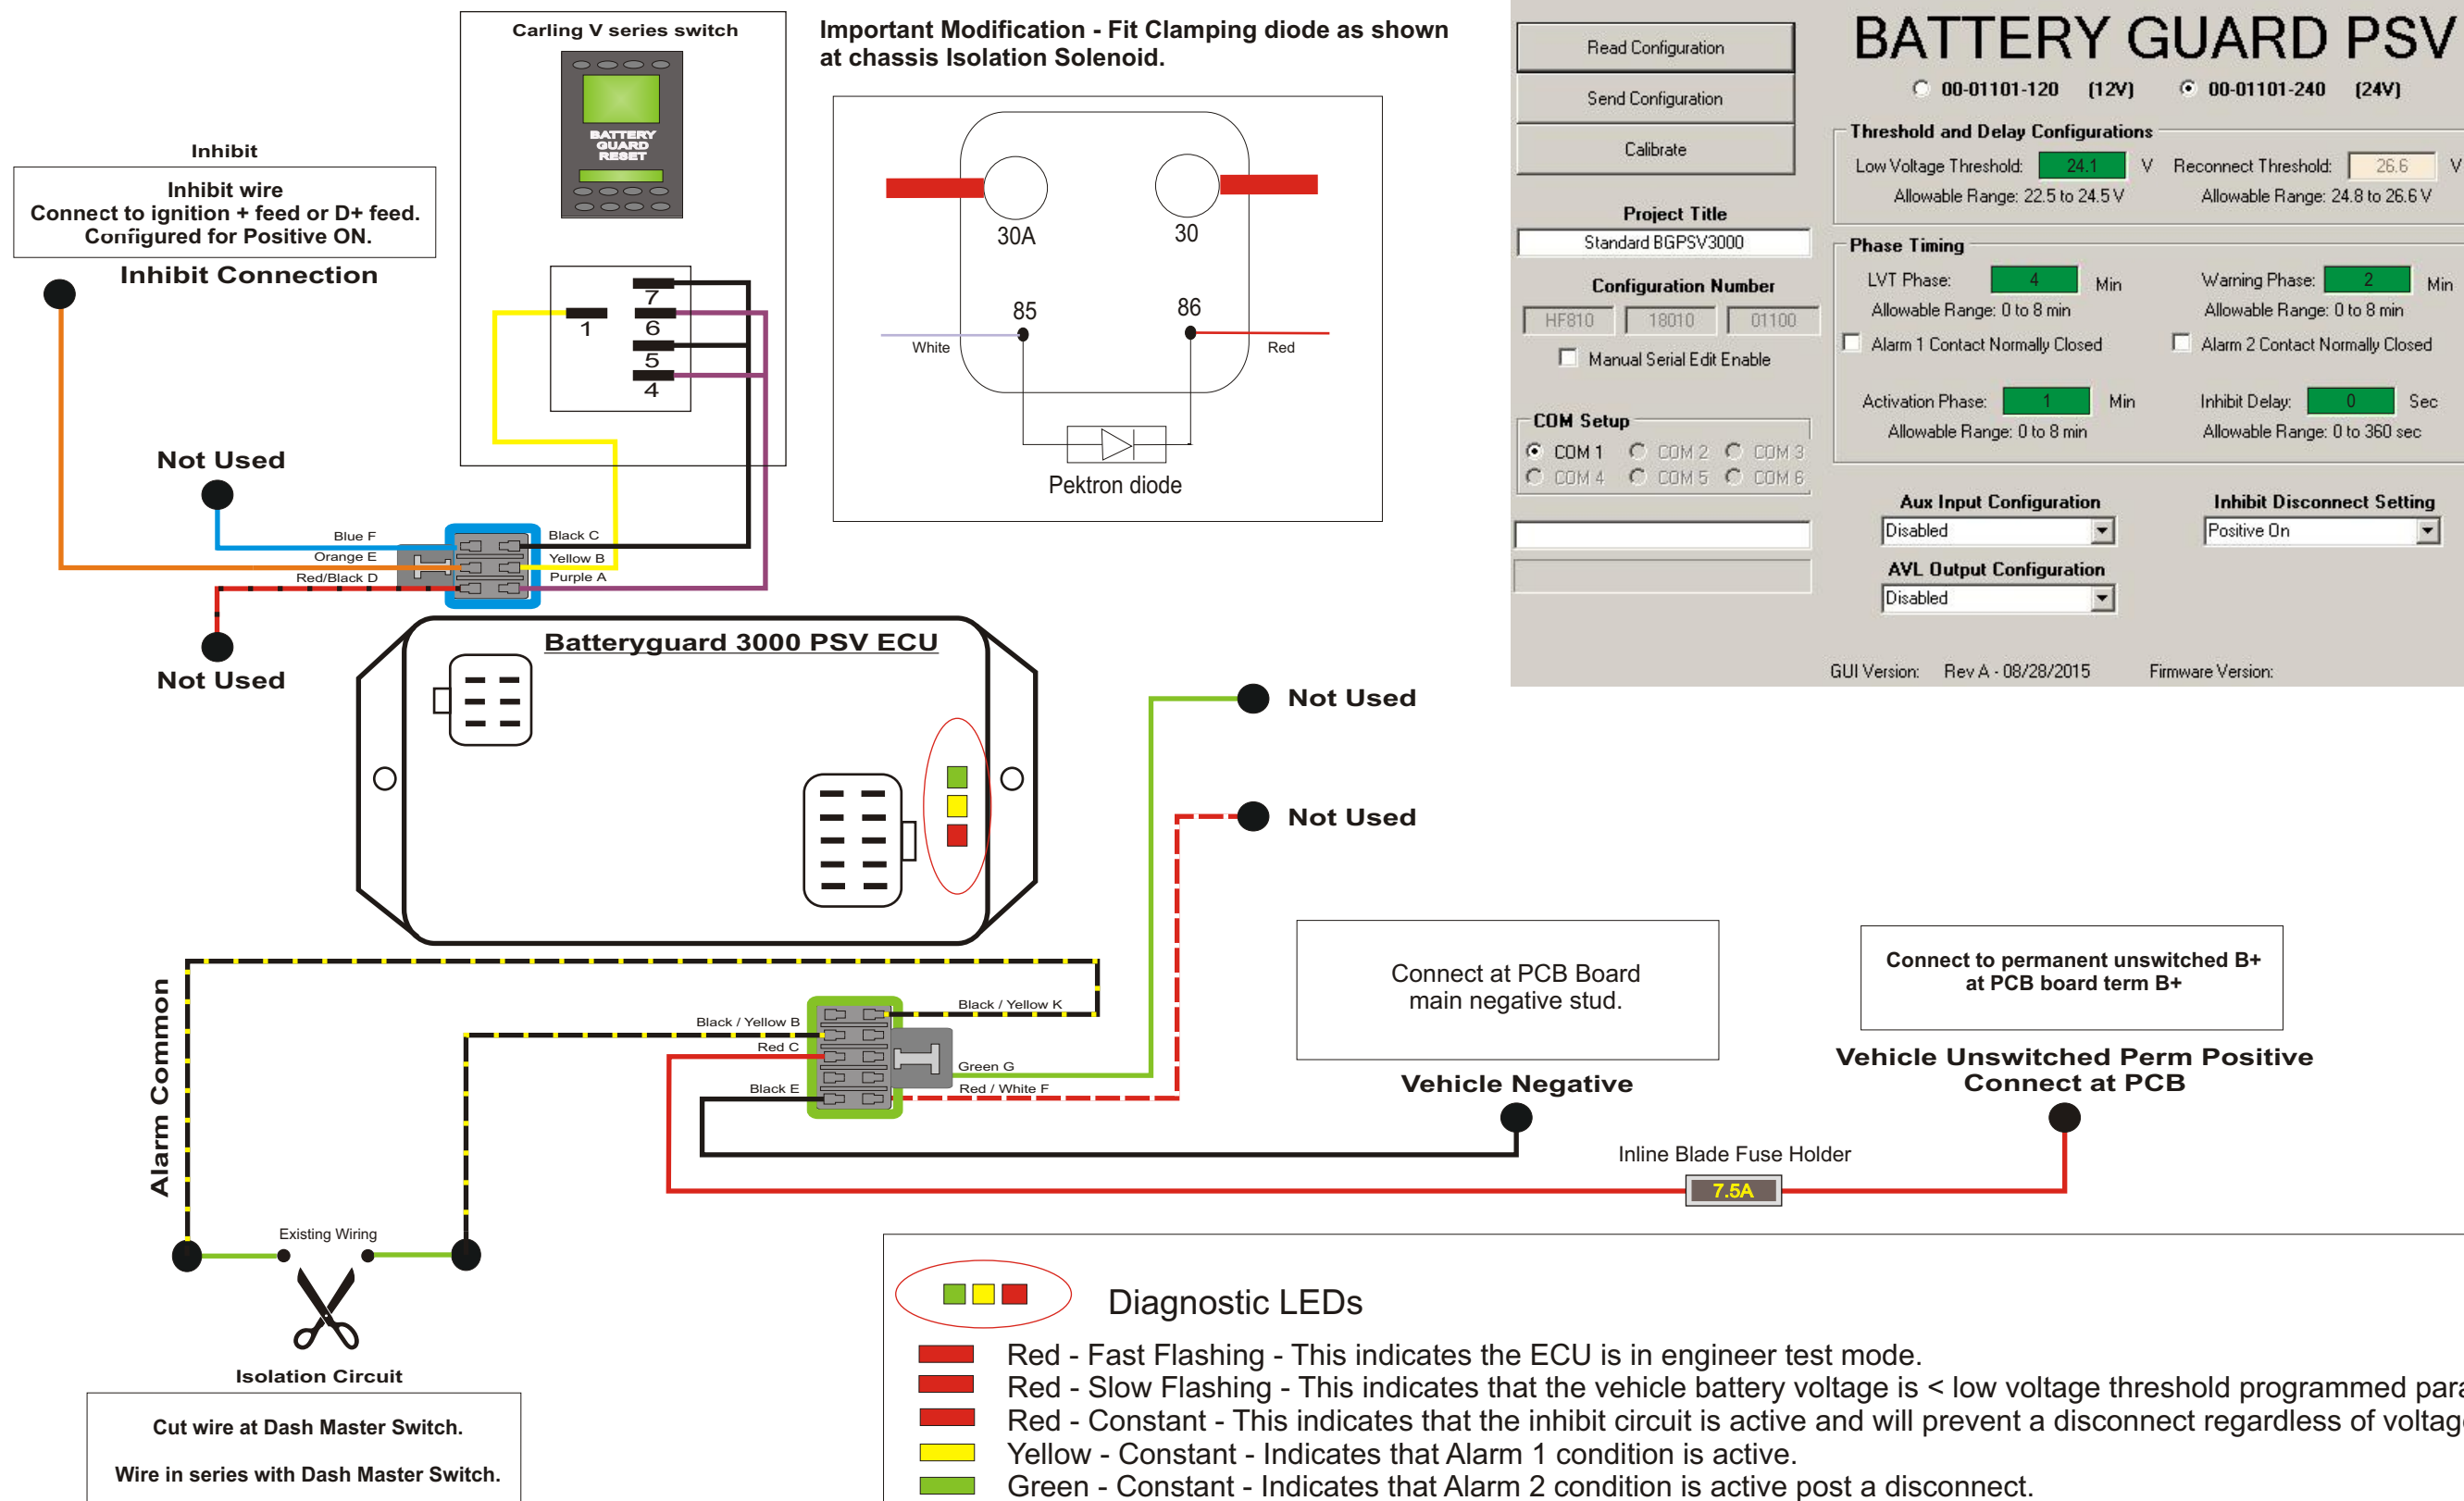
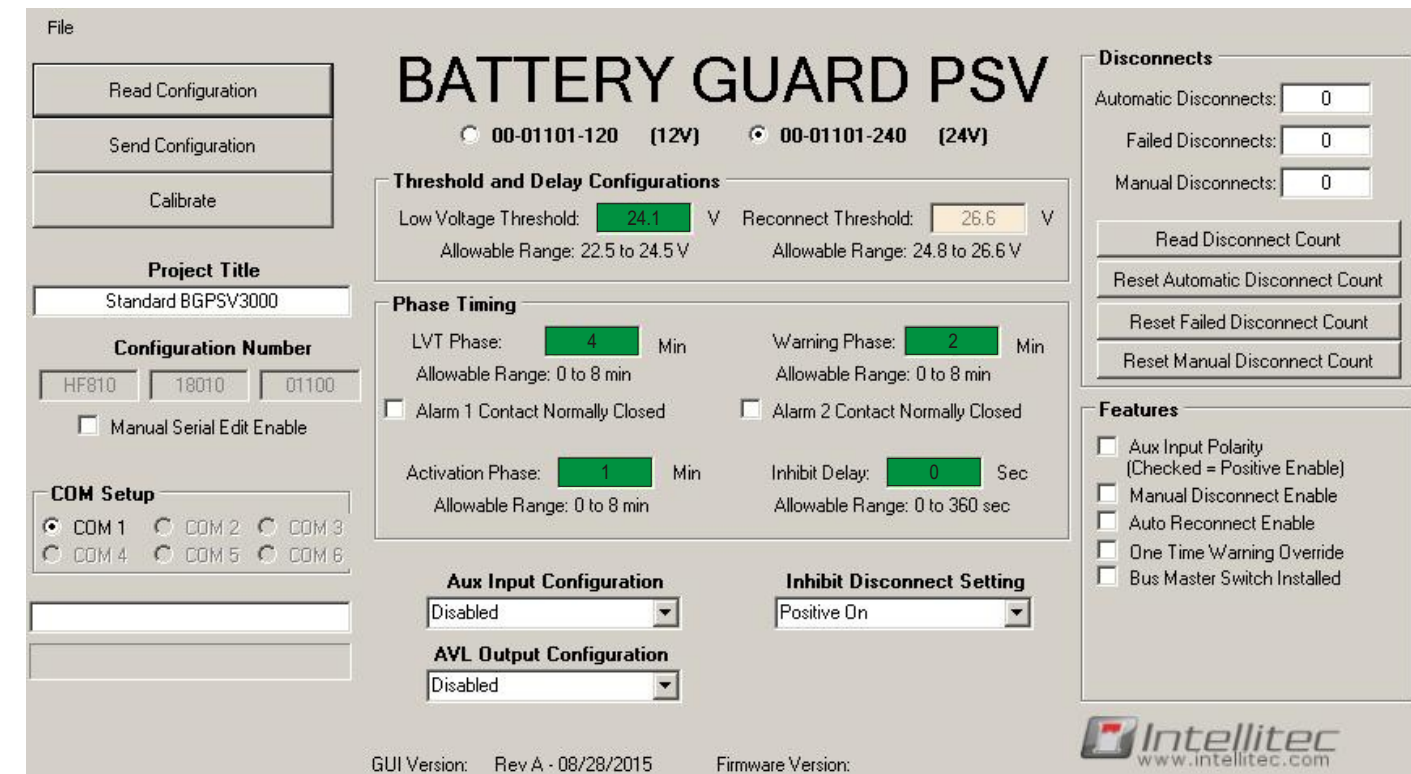
Manual Isolation Delay - N/A

Alarm 1 - 2 min after &lt;LVT

Low Voltage Threshold - 24.1V

Alarm 2 - 1 min after isolation
